JOINT HIGHWAY RESEARCH PROJECT

JHRP-75-15

USE OF PRECAST-PRESTRESSED CONCRETE FOR BRIDGE DECKS

July 30, 1975
Revised Dec. 1976
Project: C-36-56N
File: 7-4-14

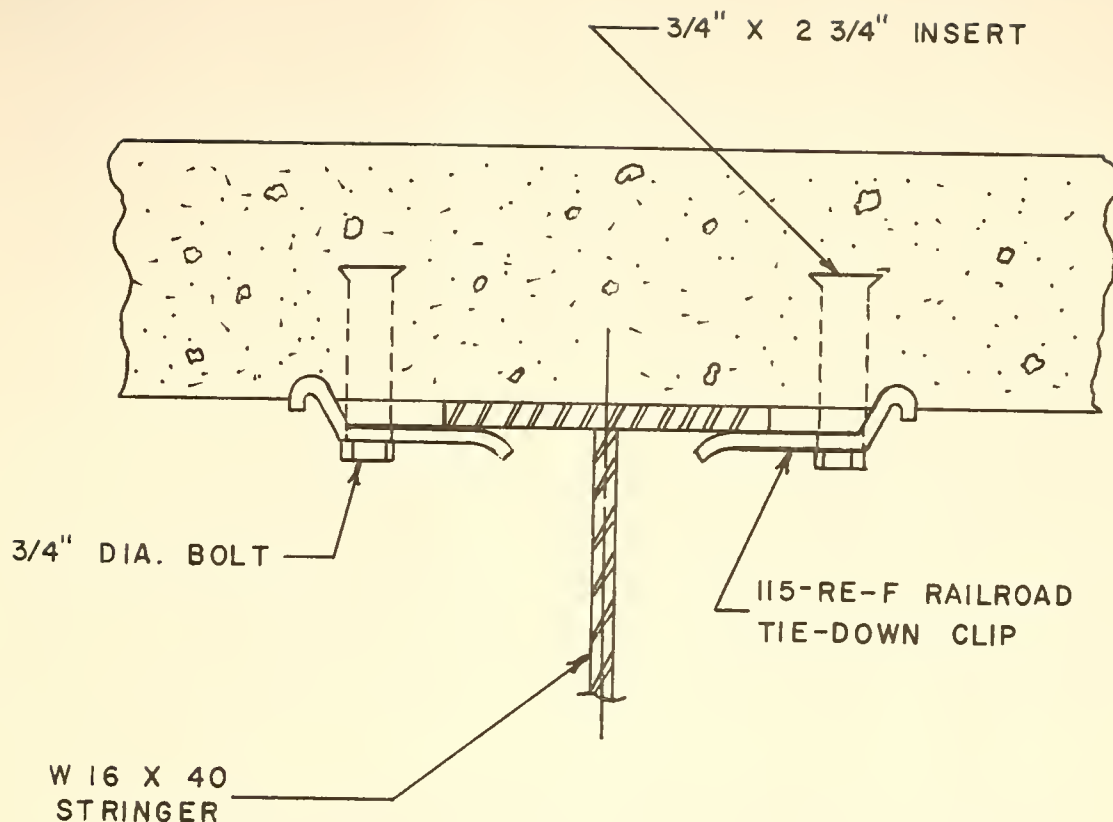
FIGURE NO. 5

Following the final post-tensioning operation all of the slabs were permanently fastened to the stringer flanges using the 115-RE-F railroad clips bolted to 3/4" diameter inserts cast in the slabs (See Figure #5). The 115-RE-F clips used were different from those specified and could not be drawn up against the lower part of the top flange because the offset spacer on the clip was deeper than the flange was thick. All of the offset spacers had to be burned off, the bolts were greased, and the bolts were tightened with an electric torque wrench to approximately 50 ft lbs. of torque.

SECTION OF A TYPICAL SLAB TIE-DOWN CONNECTION
BLOOMINGTON AND KNIGHTSTOWN BRIDGE

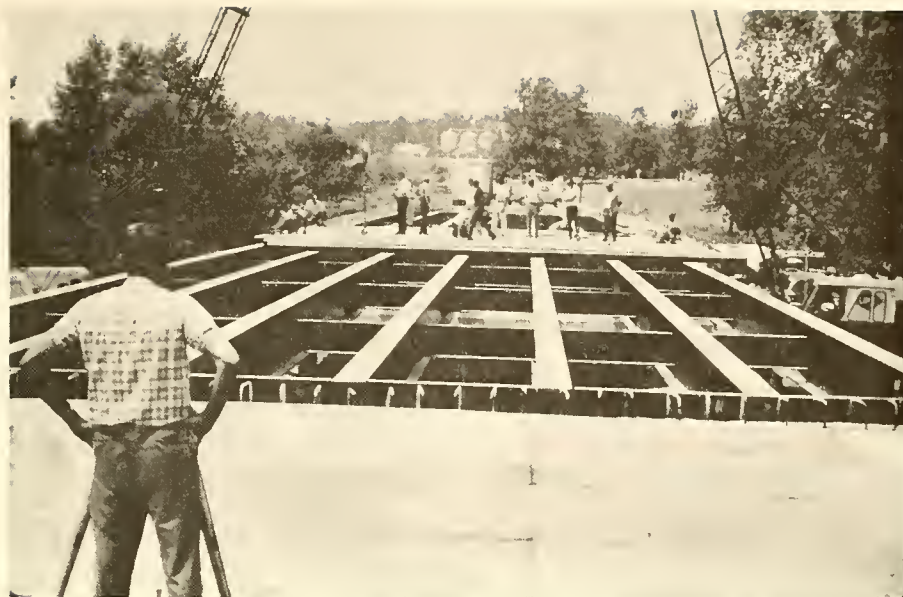
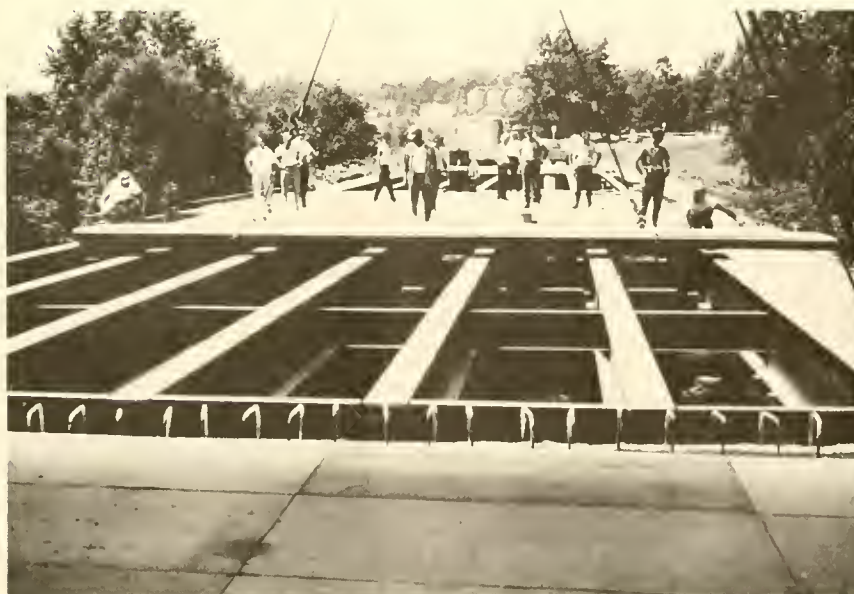
Figure #7. Precast Slab Placement at the Knightstown Bridge

were set and post-tensioned. Figure #7 shows the slab placement operation. A problem which arose during the post-tensioning operation was the appearance of eight 2'-0" long cracks which ran in the longitudinal direction of the bridge. This was due to irregularities in the top portions of the joints which caused a poor fit between adjacent units. The post-tensioning operation caused a bending stress in the slabs which fit poorly, resulting in the cracks. Due to the fact that water could seep down into these cracks and rust the pretensioning cables, a seal coat of epoxy was applied to the bridge. Integral curbs were poured in place on the bridge deck and the bridge was opened to traffic on August 6, 1970.

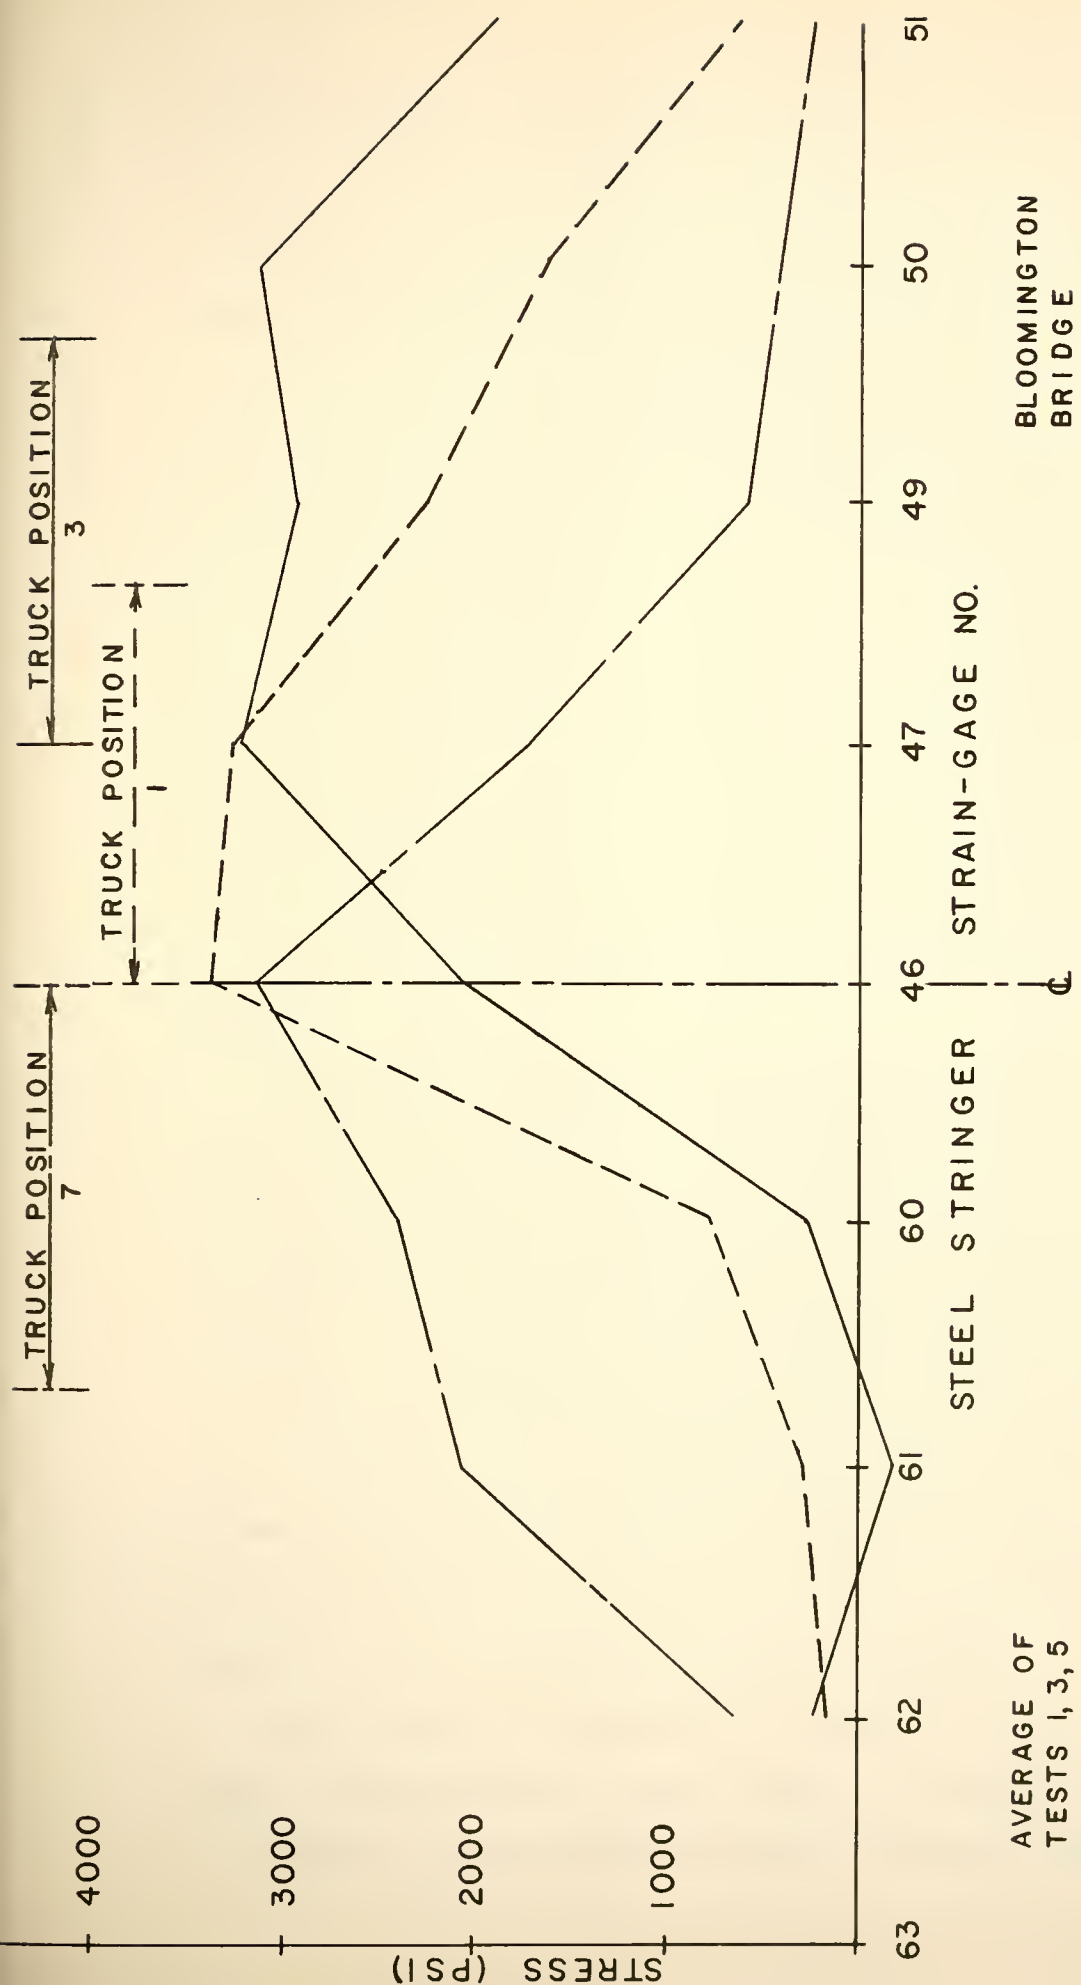
FIGURE NO. 19
DISTRIBUTION OF STRESSES AT SECTION W
FOR TRUCK POSITIONS 1, 3, AND 7.

Figure #19 indicates that the maximum stresses or moments occur in the stringers directly under the tandem axle, which was to be expected. (For truck positions #1, #3, and #7 the tandem axle of the test vehicle is centered directly over Section W. (See Figure #16). Figure #20 shows that as the test vehicle is moved away from the centerline of the stringers (i.e. Section W), the stresses at Section W decrease which also was to be expected.

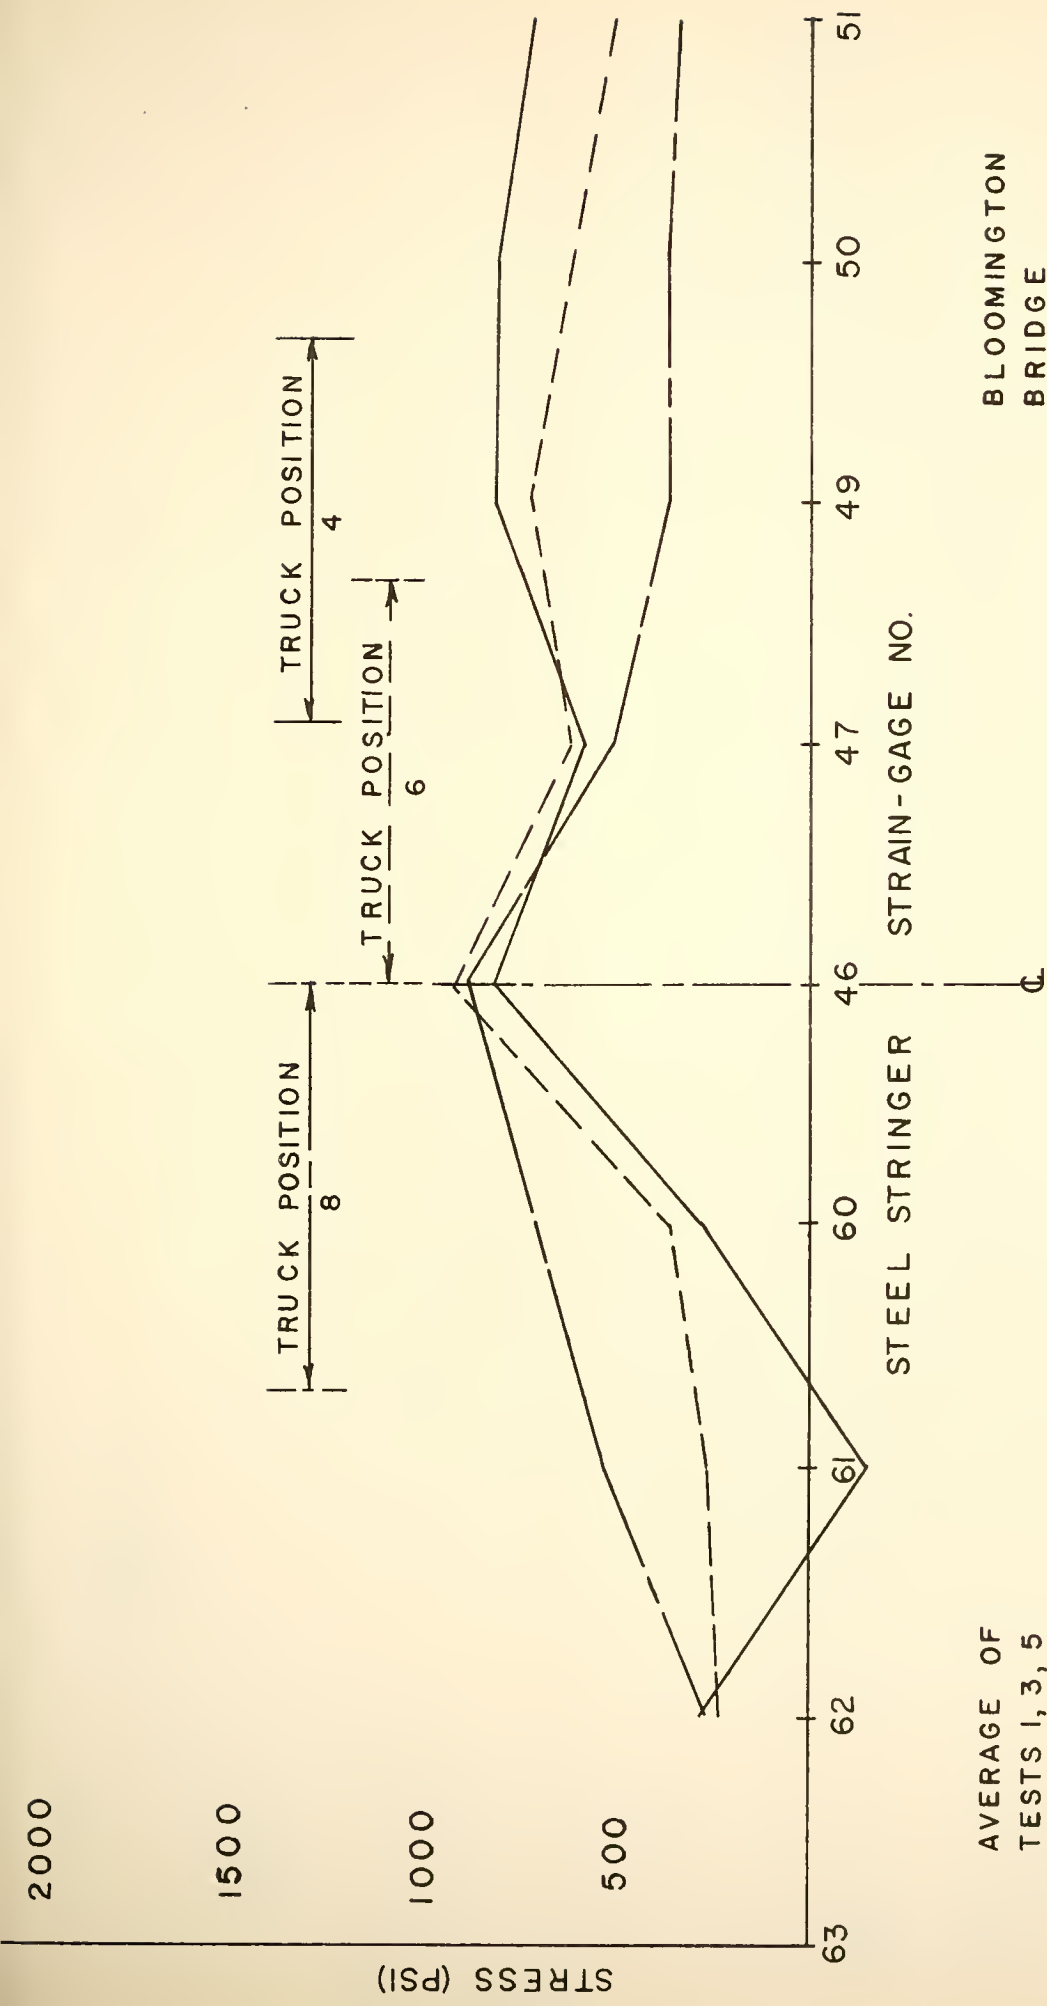
FIGURE NO. 20

DISTRIBUTION OF STRESSES AT SECTION W

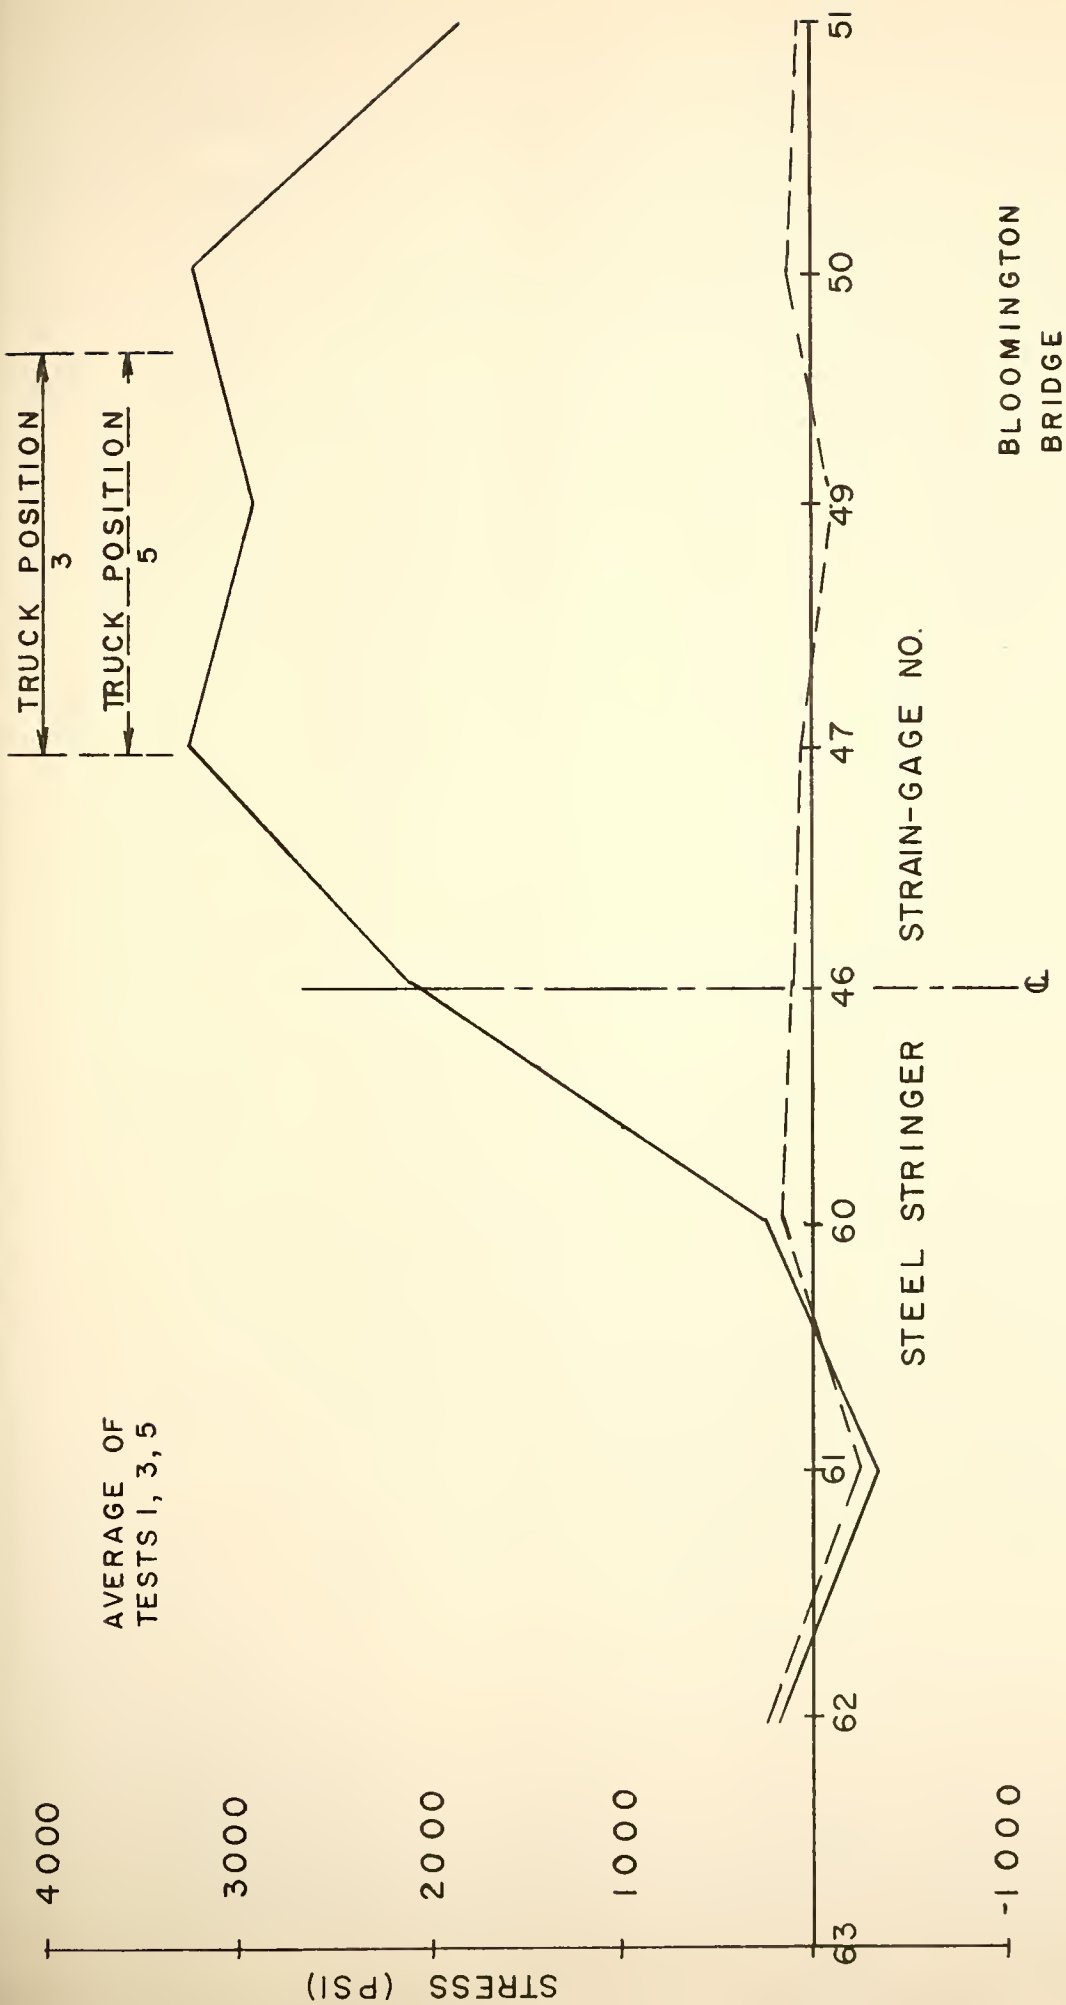
FIGURE NO. 21

Figure #21 is included to show the magnitude of the load transmitted across the floor beam by the slabs. Referring to Figure #16 it can be seen that truck position #3 is midway between the first two floor beams while truck position #5 is midway between the second and third floor beams. Figure #21 indicates that very little moment is transferred across the floor beams. This would justify disregarding the front wheel loads in the calculation of the moment under the tandem axle, provided the front and tandem axles were not located between the same two floor beams. This would also indicate that for the purposes of design, the stringers could be assumed as simply supported at their support points.

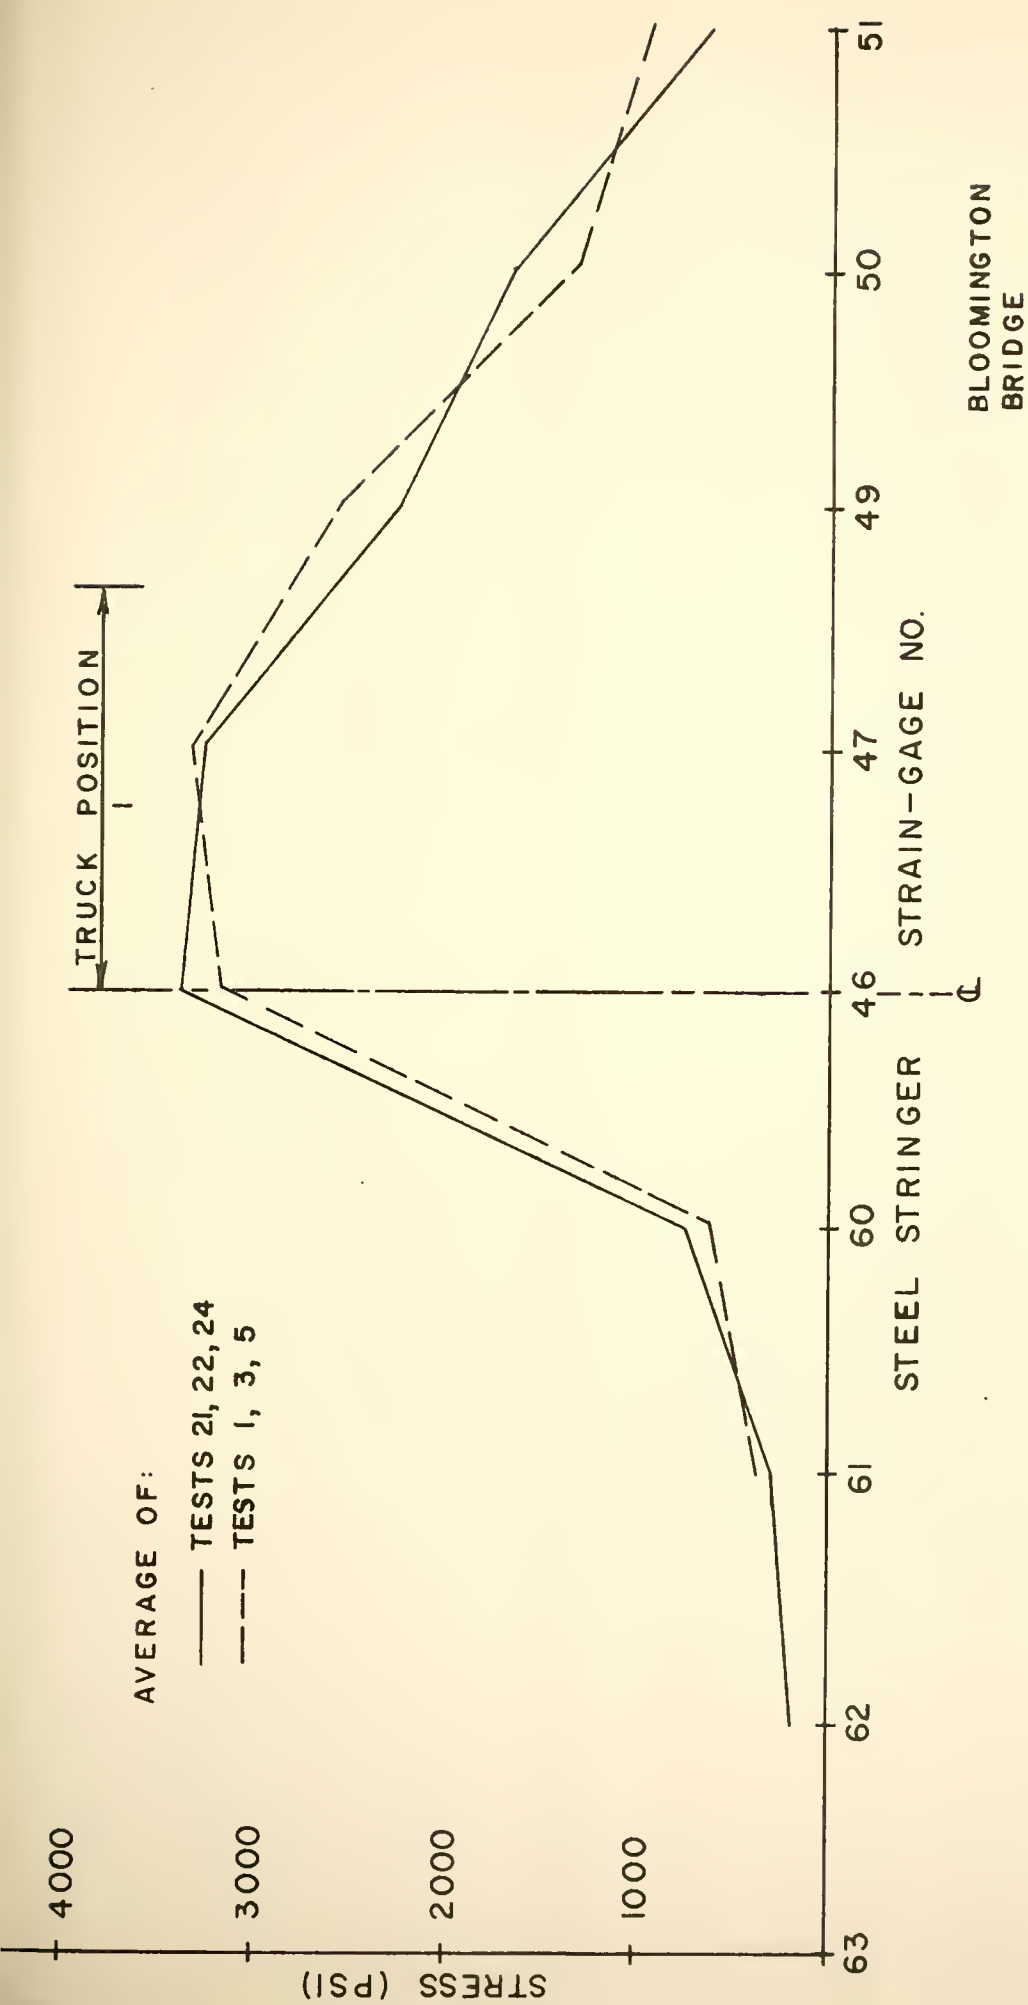
FIGURE NO. 22

In a previous section the variation of stress over a period of time for a particular gage was examined. Figures #22 and #23 indicate the change in the stress (load) distribution at Section W over a period of approximately two years. The stresses were averaged from Tests #1, 3, 5, and Tests #21, 22, 24 (See Tables B1, B2 and B3). The average of Tests #21, 22, 24 is plotted as a solid line. As was concluded for the stress variations over time for the individual strain gages, the load distribution has remained virtually unchanged over the two year time period.

TIME EFFECT ON THE DISTRIBUTION OF
 STRESS FOR TRUCK POSITION I AT SECTION W

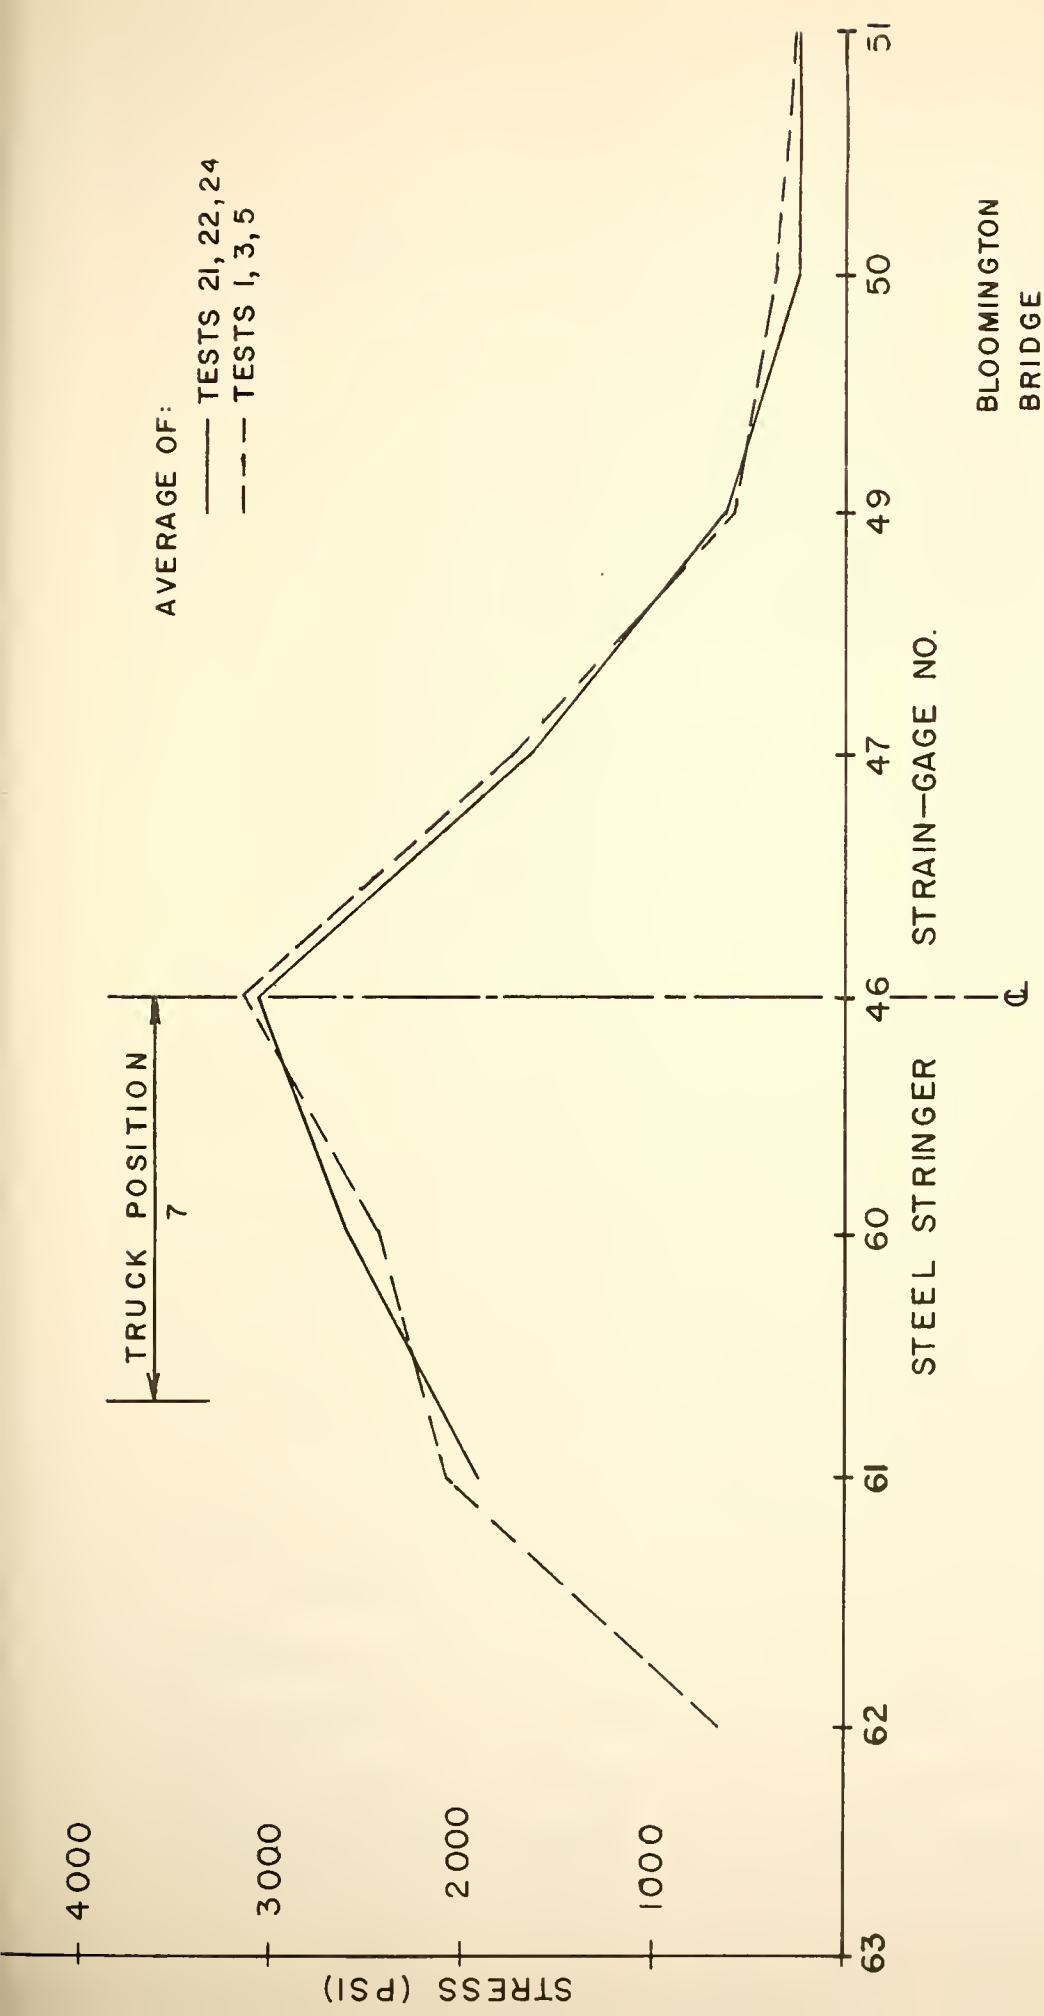
FIGURE NO. 23

TIME EFFECTS ON THE DISTRIBUTION OF STRESSES FOR TRUCK POSITION 7 AT SECTION W
